Riverview-Trenton Railroad Status Update

Community Advisory Group (CAG) Meeting
May 8, 2025

EGLE Materials Management Division

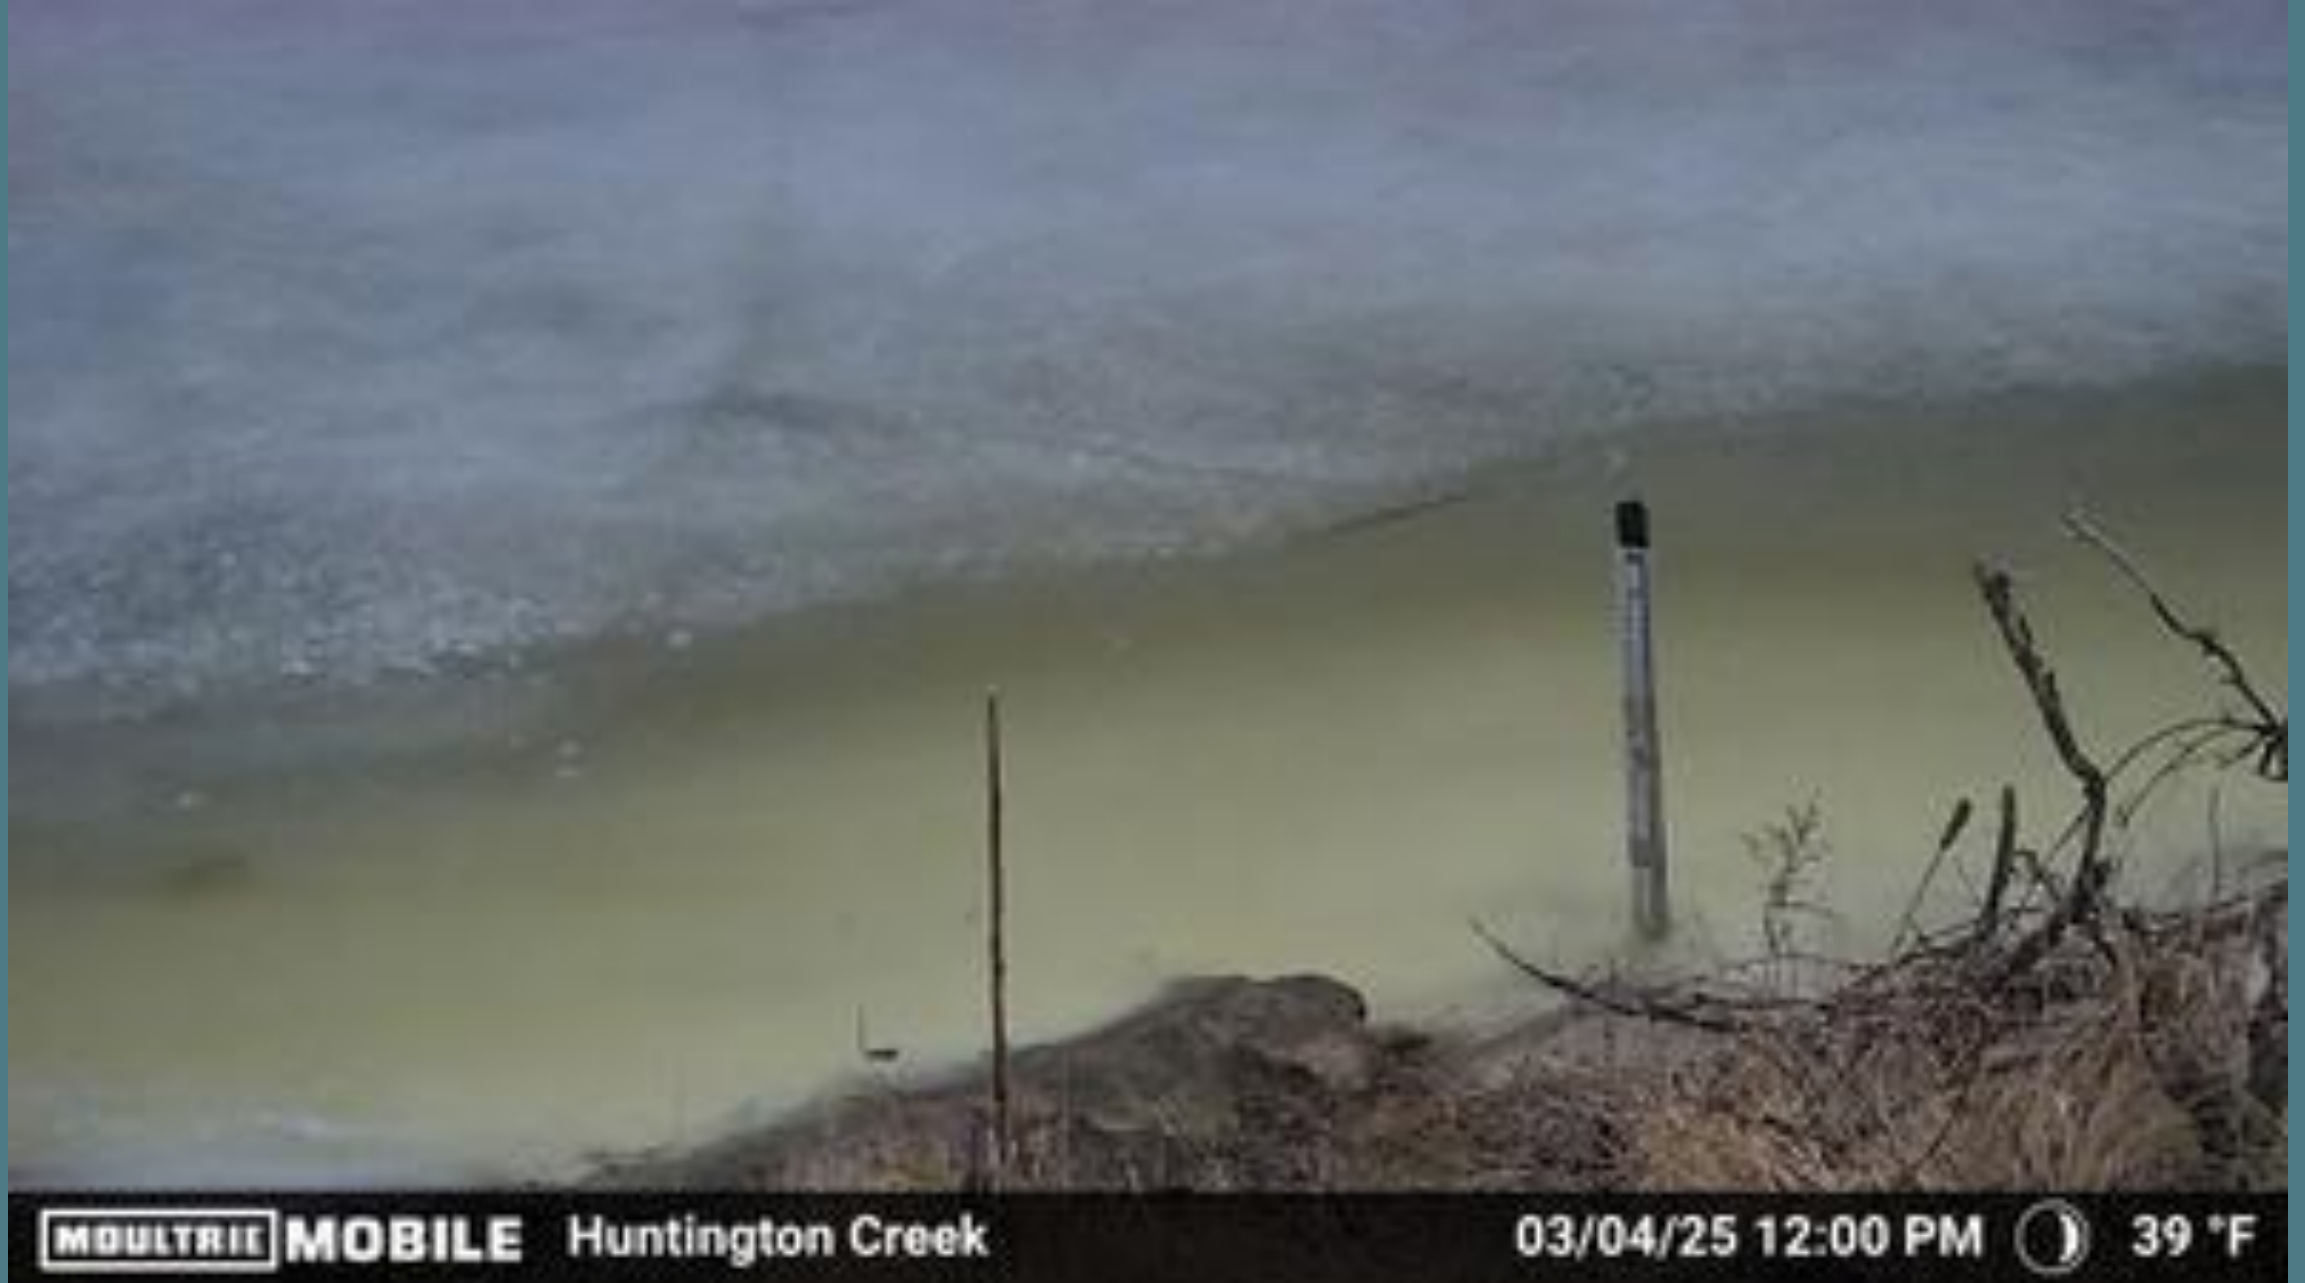
03/04/25 12:00 PM

- 3/4/25 – EGLE reviewed daily photo of creek and contacted RTRR to address the visible seep in the image. RTRR responded the same day with a plan to immediately install booms.
- 3/7/25 – Polypropylene booms installed by RTRR along shoreline where the groundwater seep is entering the creek.
- 3/11/25 - EGLE visited the site to assess the booms and site conditions.
 - Observed high pH solution entering the creek at the outfall located just north of Jefferson Ave bridge.
 - The booms appear to be effectively segregating the surficial contamination within the boomed area. However, the subsurface contamination is not addressed.
 - EGLE deployed a kayak and collected three surface water samples (Photos and Figure on next slides).

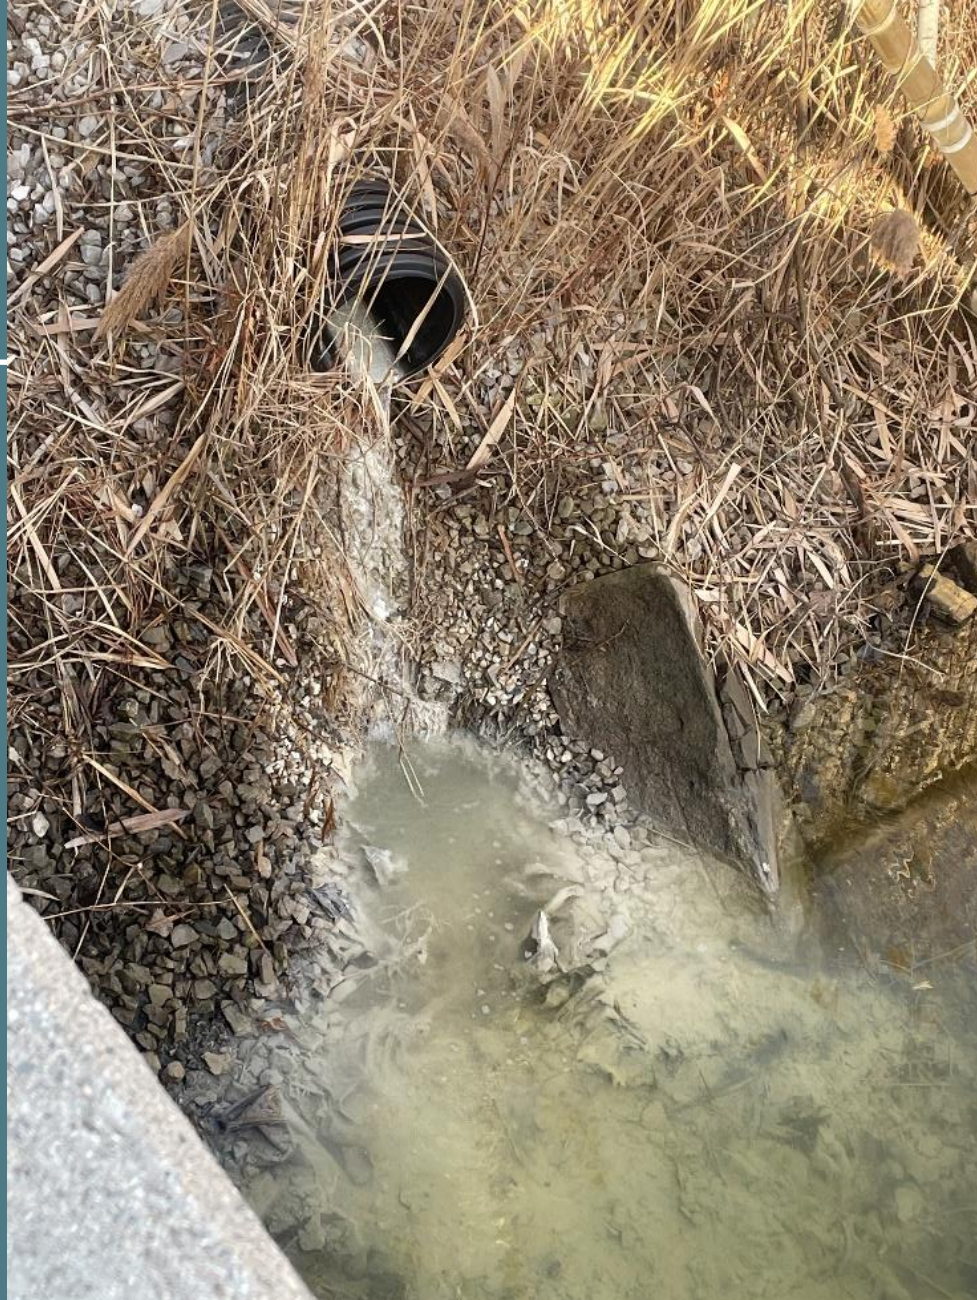
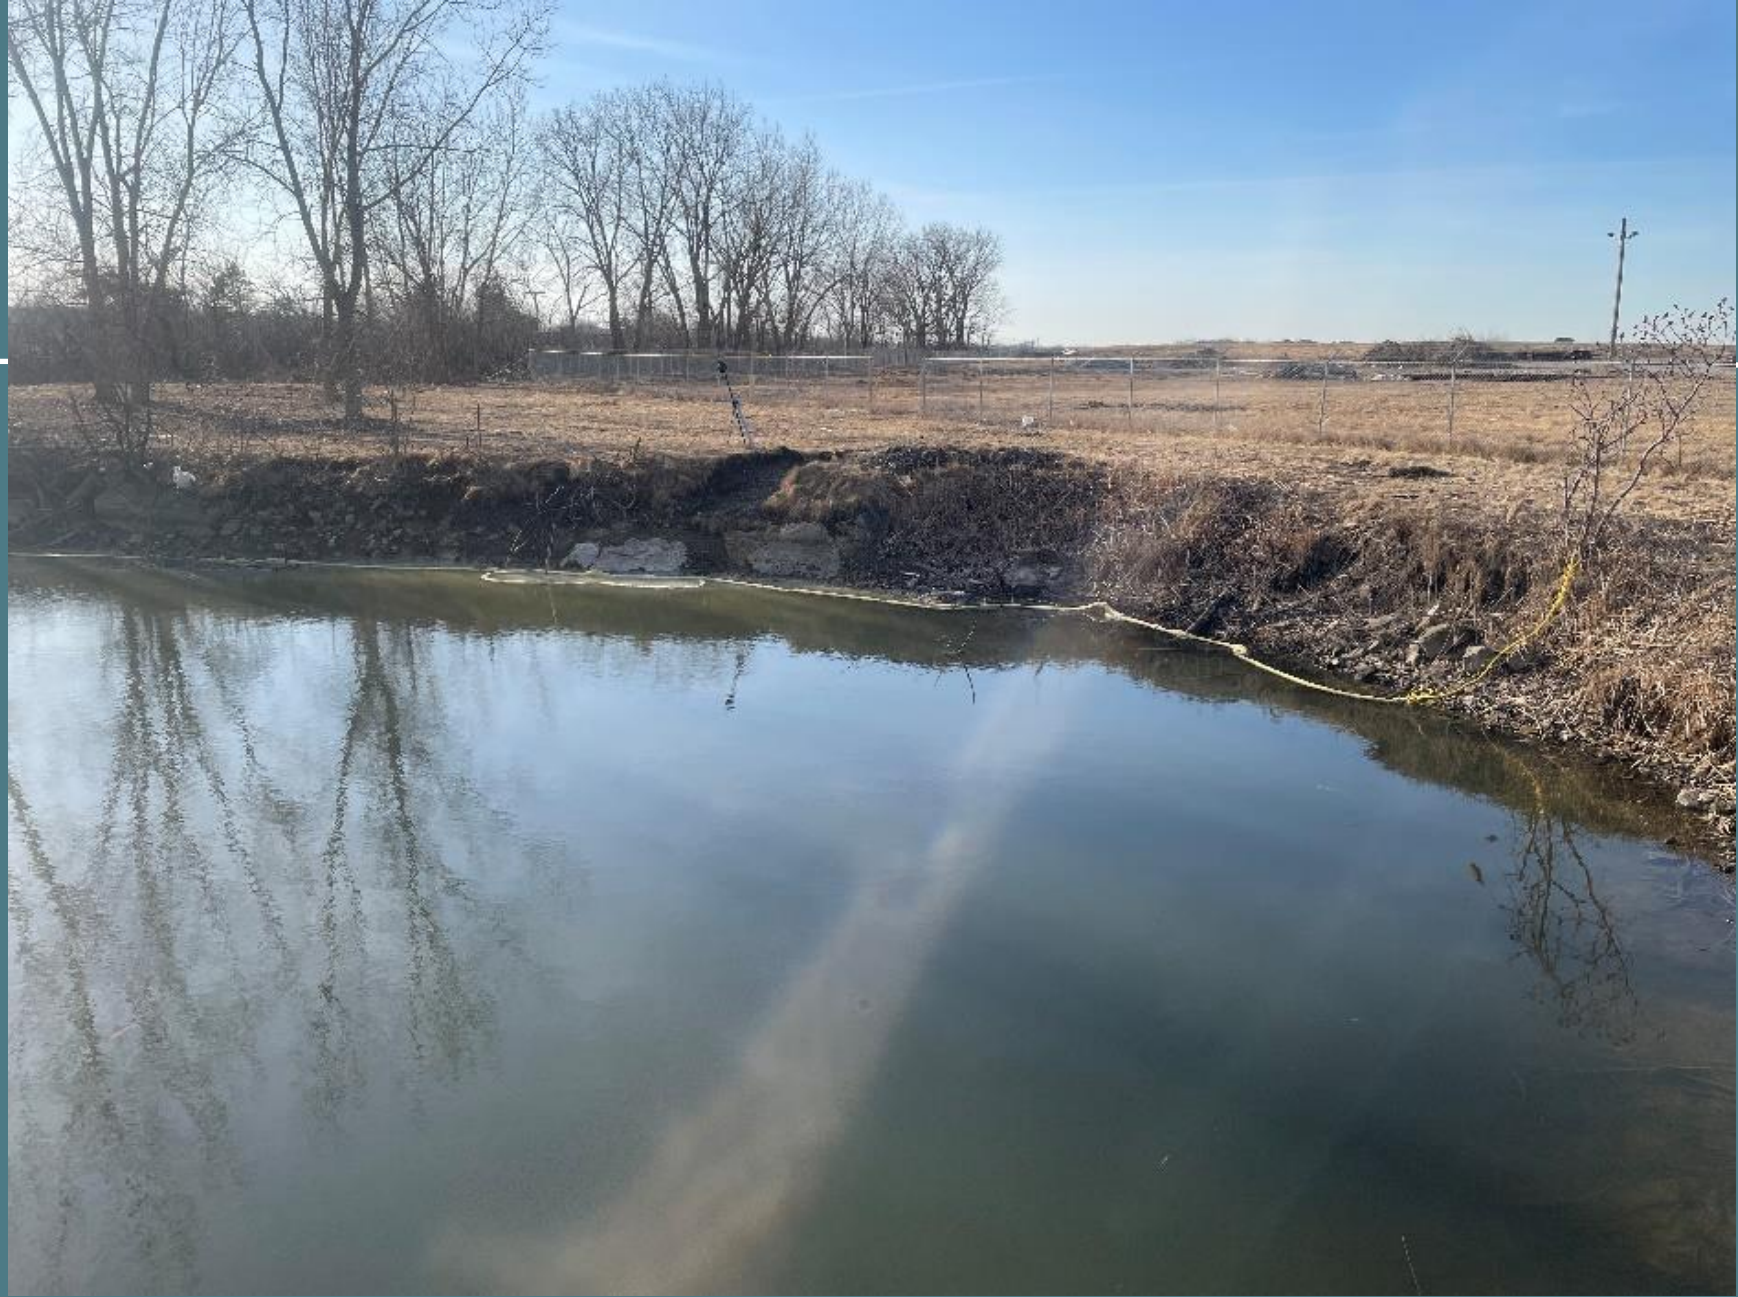
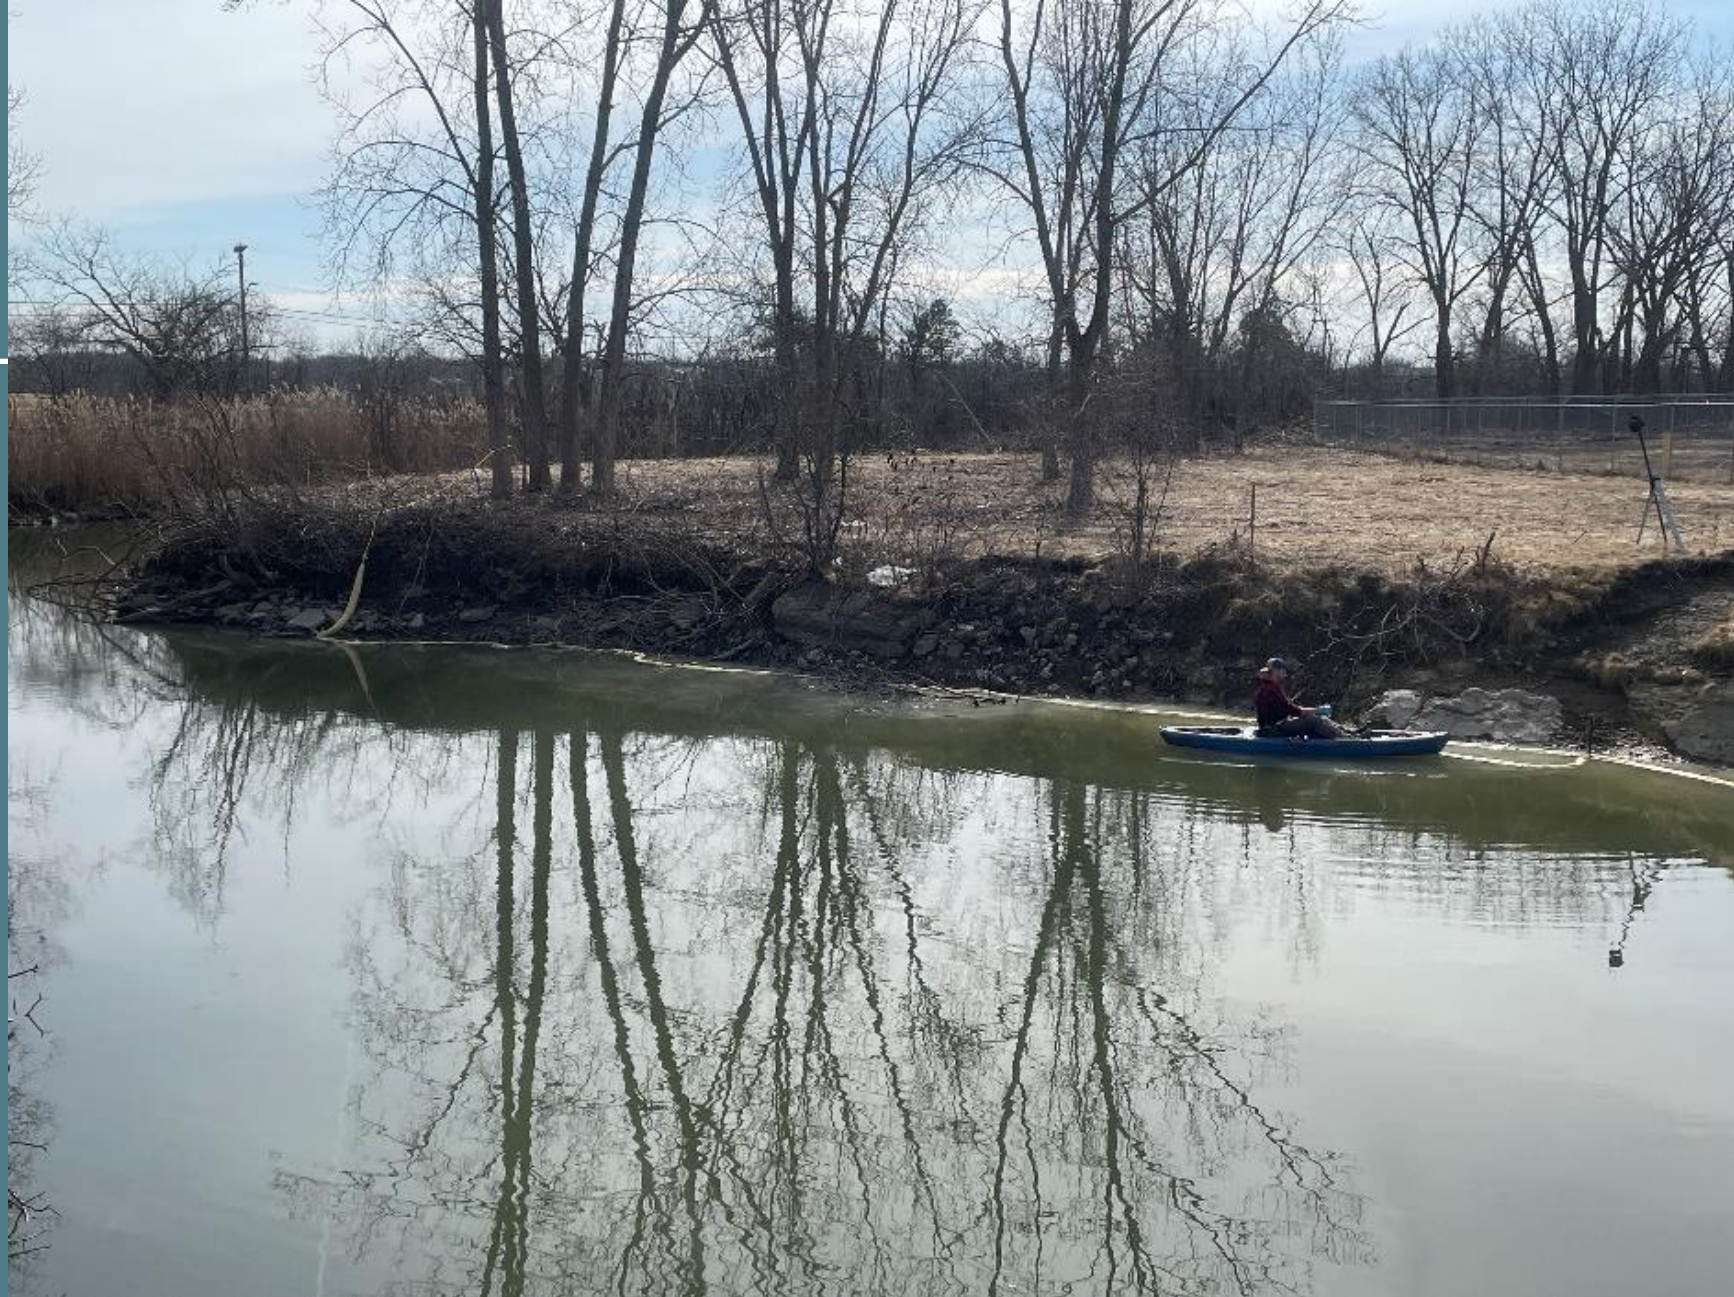
- **Sample ID: Seep** – No exceedances
- **Sample ID: Surface** – No exceedances
- **Sample ID: Outfall** – Silver (0.3 ug/L), Dibenzofuran (8.5 ug/L), Fluoranthene (1.8 ug/L), and Naphthalene (20 ug/L) all exceeded the GSIC. Phenanthrene (11ug/L) exceeded both the GSIC and FAV.

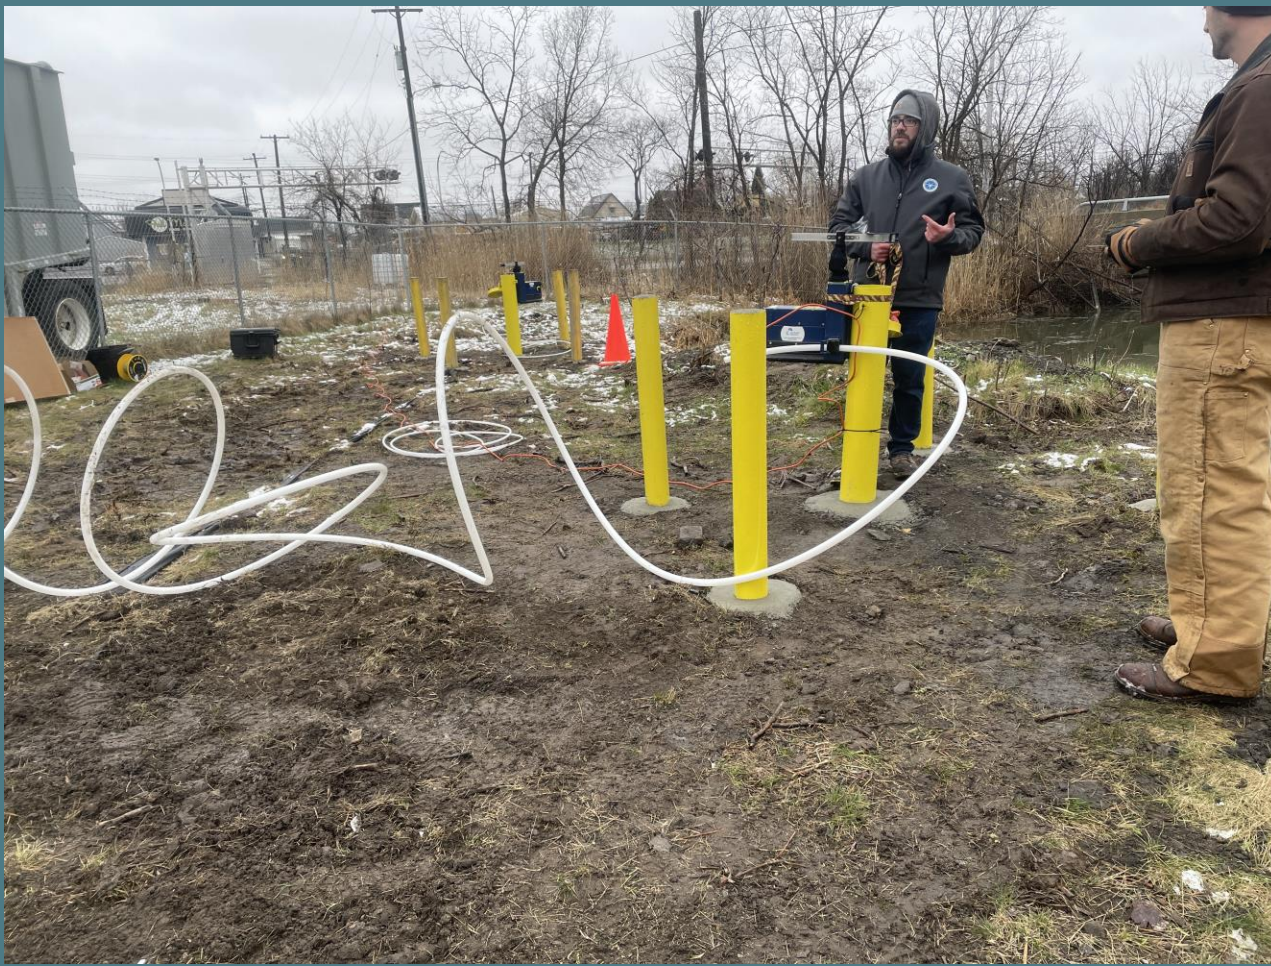
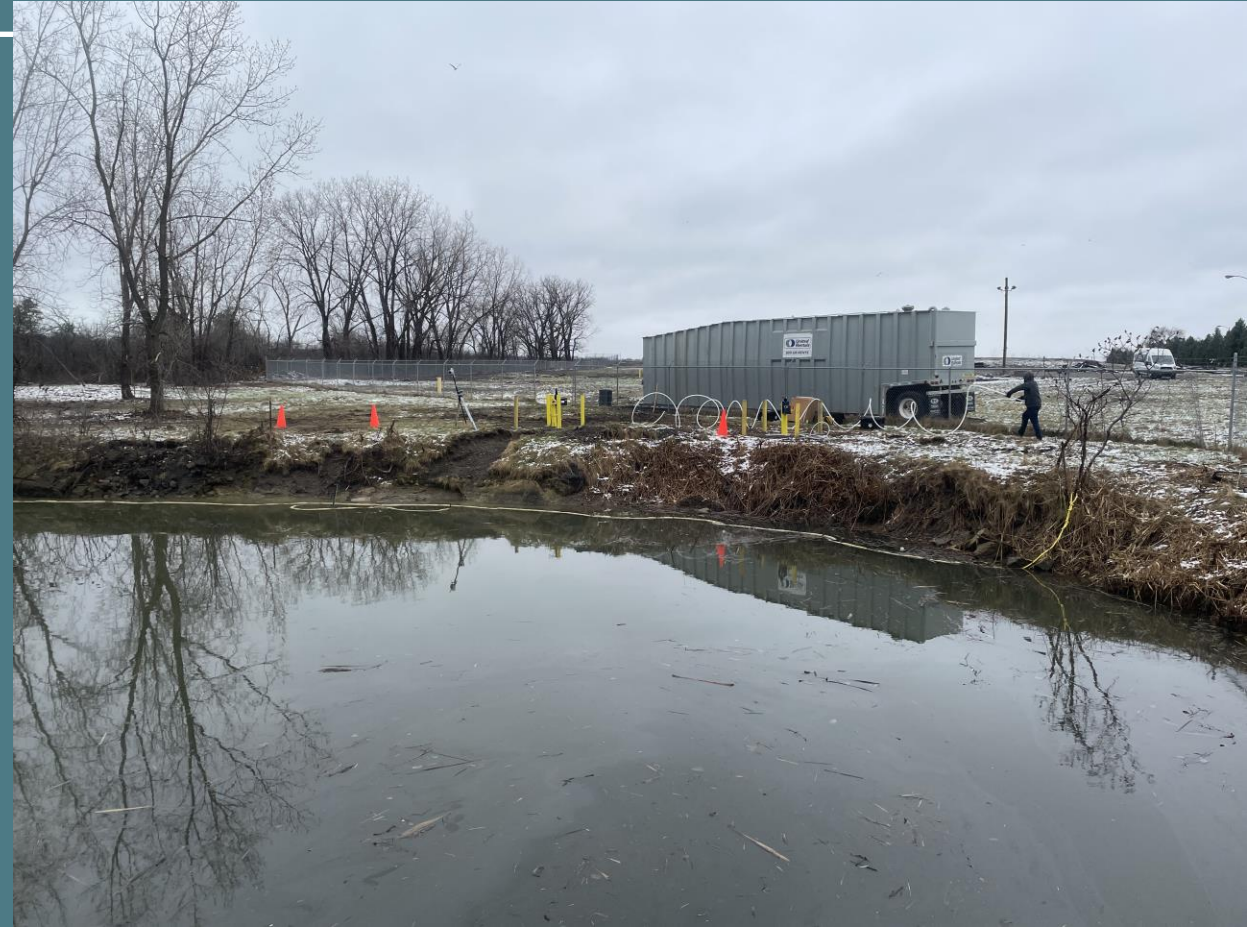
Photos from EGLE site visit on April 10th

- 4/10/25 – EGLE visited the site to observe installation and setup of the extraction wells and to collect a groundwater sample from MW-7 located in the vicinity of the new wells.
 - The outfall located north of the Jefferson Ave bridge was discharging high pH solution (pH 10-11).
 - Groundwater sample showed only vinyl chloride exceeding the DWC but not the GSIC.

Groundwater extraction wells were installed on April 9th and 10th, 2025.
